NAMDET Survey: T34 battery Performance July 2020

MDSO WebEx 2nd September 2020

Patricia Lee, Medical Device Training Manager

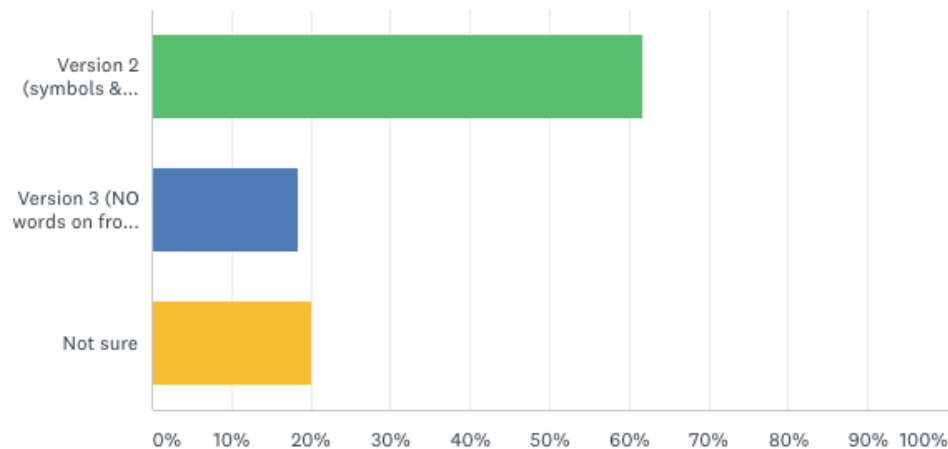
Q1

What version of T34 was in use at the time of battery failure?

Answered: 60 Skipped: 0

ANSWER CHOICES	RESPONSES	
Version 2 (symbols & words on front panel buttons)	61.67%	37
Version 3 (NO words on front panel buttons, only symbols)	18.33%	11
Not sure	20.00%	12
TOTAL		60

- The T34 battery performance survey clearly shows a wide range of battery issues
 - Version 2 and Version 3 are affected
 - There are a wide range of serial numbers affected
 - 6LR61 is the main type being used(as recommended by BD Ltd.)
 - Multiple battery makes are causing concerns: the NX, NX POWER TECH and PROCELL seem to be the main protagonists
 - NX batch number 113 and 169, (already known) and now 095 (latest NX) are common
 - Vast majority fail within first 12 hours
 - Not all T34s stop working, and some batteries recover
 - Vast majority have no issues with connections, or battery contact
 - The affect on patients wellbeing and care is significant !!!
-
- NHS Wales (July 2020) has added the DURACELL ULTRA to the stockist..
 - We continue to monitor
-
- THANK YOU FOR Your Contributions and Thank You for Listening.... ANY QUESTIONS?**

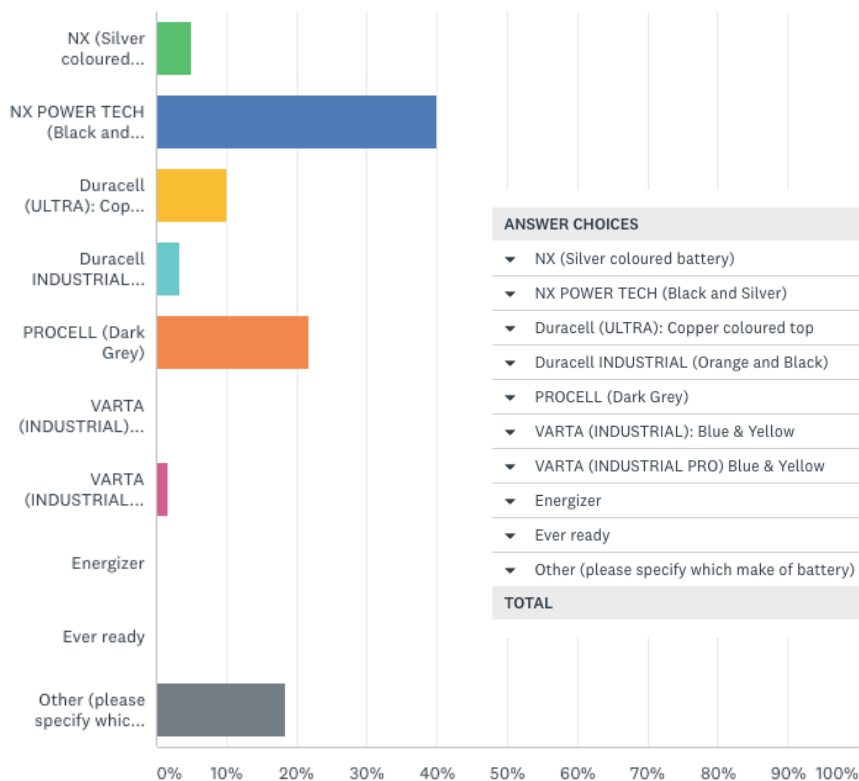
Q3 What manufacture of battery was being used at the time?

Answered: 60 Skipped: 0

ANSWER CHOICES	RESPONSES
▼ NX (Silver coloured battery)	5.00% 3
▼ NX POWER TECH (Black and Silver)	40.00% 24
▼ Duracell (ULTRA): Copper coloured top	10.00% 6
▼ Duracell INDUSTRIAL (Orange and Black)	3.33% 2
▼ PROCELL (Dark Grey)	21.67% 13
▼ VARTA (INDUSTRIAL): Blue & Yellow	0.00% 0
▼ VARTA (INDUSTRIAL PRO) Blue & Yellow	1.67% 1
▼ Energizer	0.00% 0
▼ Ever ready	0.00% 0
▼ Other (please specify which make of battery)	Responses 18.33% 11
TOTAL	60

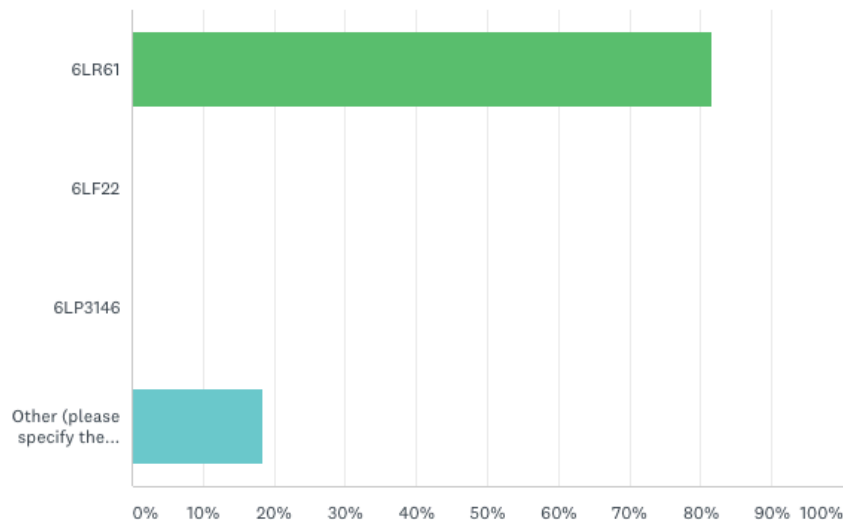
Q4

What battery type was being used at the time?

Answered: 60 Skipped: 0

ANSWER CHOICES	RESPONSES	
▼ 6LR61	81.67%	49
▼ 6LF22	0.00%	0
▼ 6LP3146	0.00%	0
▼ Other (please specify the type)	Responses 18.33%	11
TOTAL		60

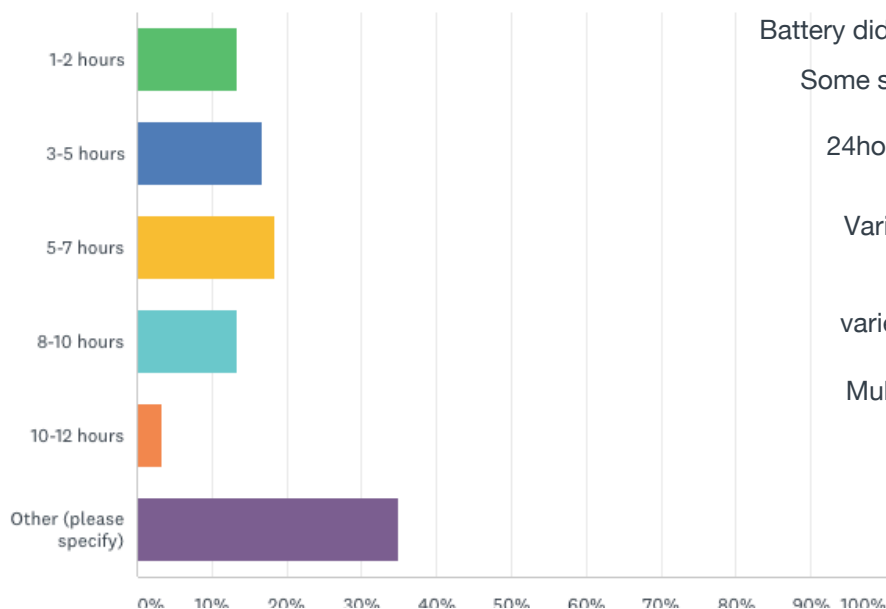
Q6 How long after pressing START, before the battery failed?

Answered: 60 Skipped: 0

ANSWER CHOICES	RESPONSES
▼ 1-2 hours	13.33% 8
▼ 3-5 hours	16.67% 10
▼ 5-7 hours	18.33% 11
▼ 8-10 hours	13.33% 8
▼ 10-12 hours	3.33% 2
▼ Other (please specify)	Responses 35.00% 21
TOTAL	60

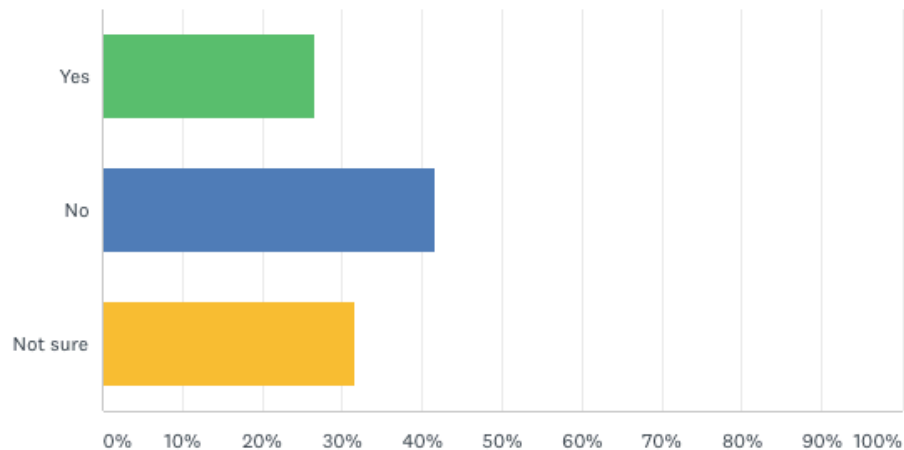
Q7 Did the faulty battery recover and allow the T34 to start again?

Answered: 60 Skipped: 0

ANSWER CHOICES	RESPONSES	
▼ Yes	26.67%	16
▼ No	41.67%	25
▼ Not sure	31.67%	19
TOTAL		60

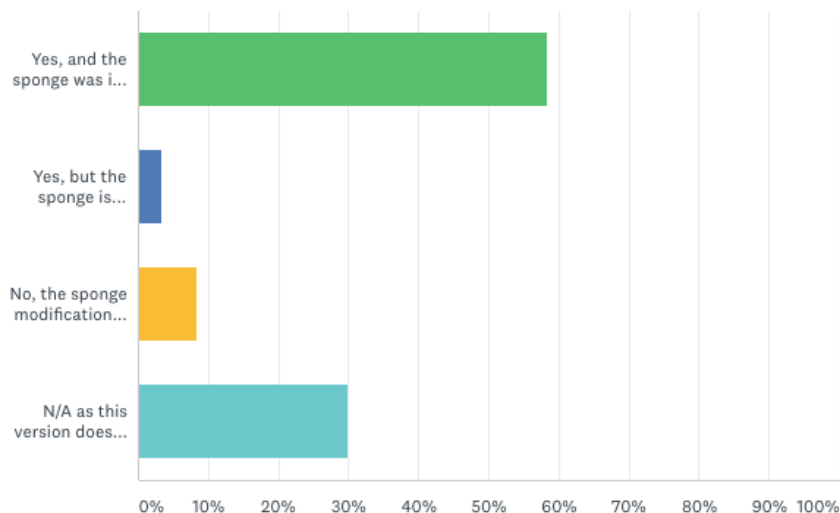
Q8

Did the T34 have the battery compartment 'sponge modification' in place?

Answered: 60 Skipped: 0

ANSWER CHOICES	RESPONSES	
▼ Yes, and the sponge was in good condition	58.33%	35
▼ Yes, but the sponge is damaged or not fitted properly	3.33%	2
▼ No, the sponge modification has not yet been carried out	8.33%	5
▼ N/A as this version does not require the sponge modification	30.00%	18
TOTAL		60

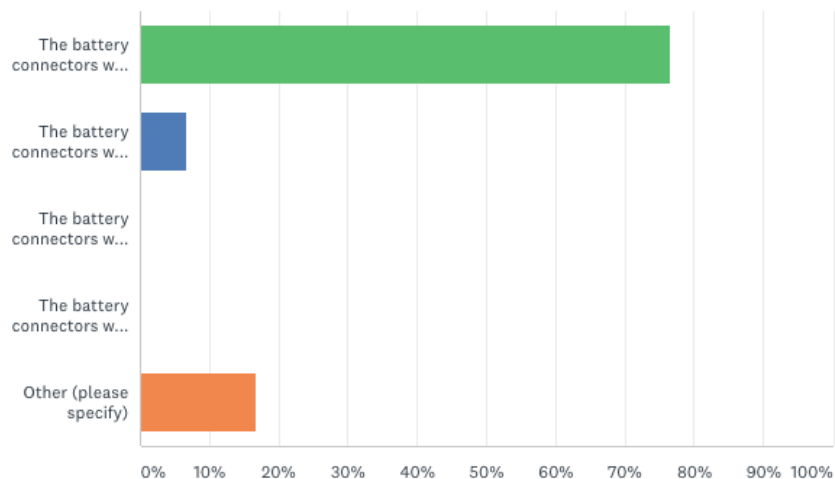
Q9 What about the battery connectors of the T34?

Answered: 60 Skipped: 0

ANSWER CHOICES	RESPONSES	
▼ The battery connectors were in GOOD condition and the battery making GOOD contact	76.67%	46
▼ The battery connectors were in GOOD condition but the battery was making POOR contact	6.67%	4
▼ The battery connectors were in POOR condition and the battery was making GOOD contact	0.00%	0
▼ The battery connectors were in POOR condition and the battery was making POOR contact	0.00%	0
▼ Other (please specify) Responses	16.67%	10
TOTAL		60
